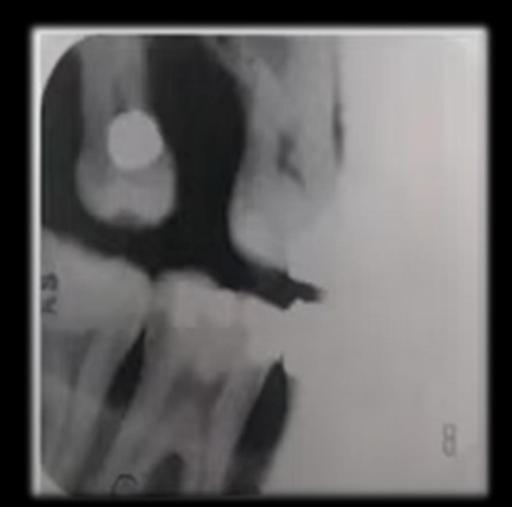
Cone cut

unexposed area result from positioning fault when the x –ray beam not completely cover the film during exposure

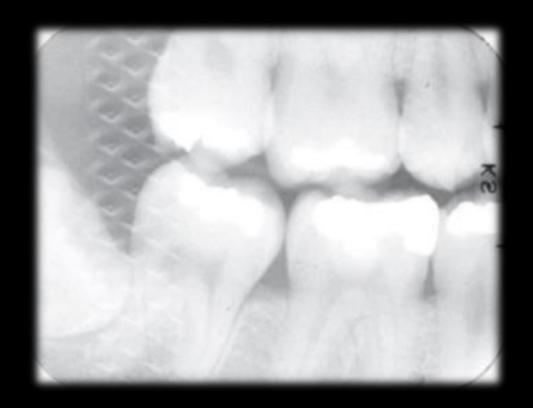
Back side exposure

When the film placed in wrong position making the non exposure side facing the beam, the result is the image with the pattern of the lead foil is evident

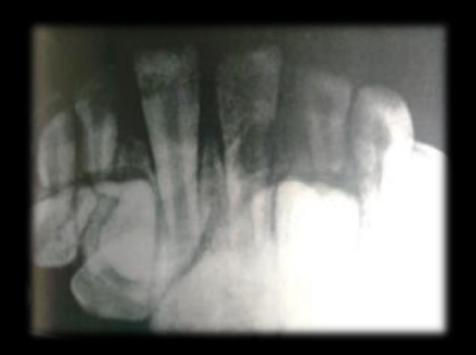
Double exposure

The same X-ray film used and exposed twice to X-ray this result in excessive dense and blurred image

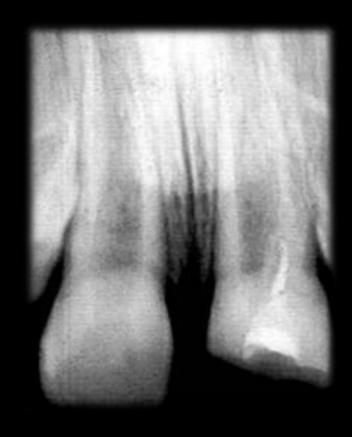
Elongated image

Vertical angulation of X – ray tube was too shallow

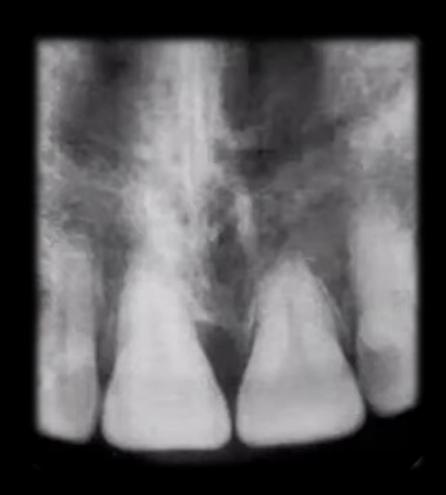
Shortened image

Vertical angulation was too steep

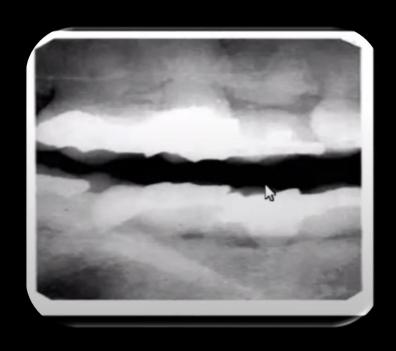
Over lapping of adjacent structures

When horizontal angulations was incorrect

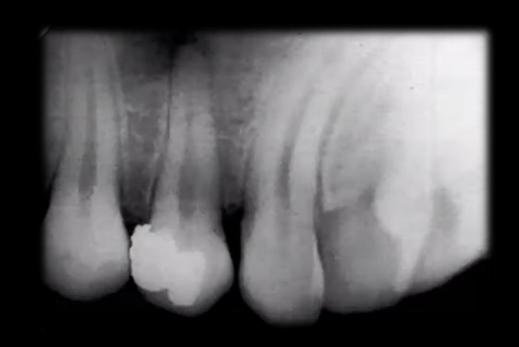
Blurred film

Due to excessive bending of the film during placement for exposure

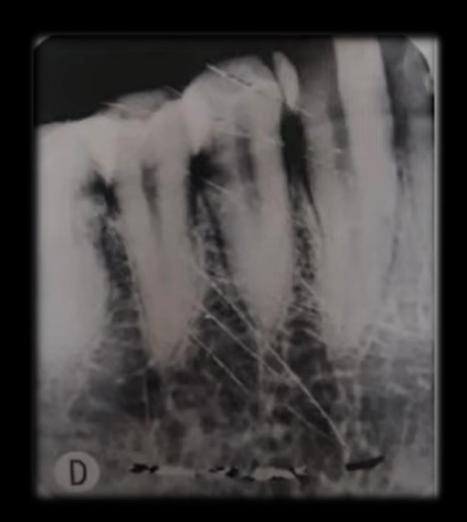
Scratched film

When the film is processed in manual processor, the soft emulsion is easily scratched due to rough handling of the film, ex. Scratched by holder, tank or nails.

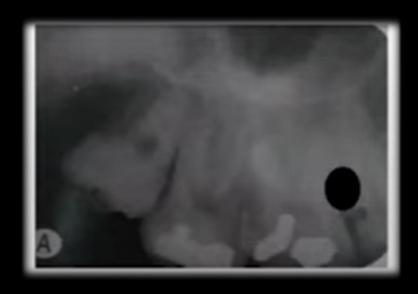
Developer Spot

Black dots or Dark spots on the film caused by drops of developer solution that was accidently spilled on the film before it was developed.

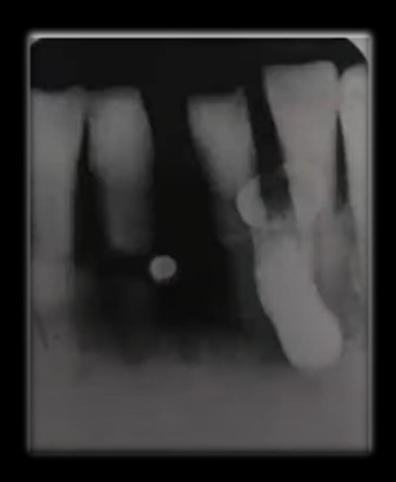
Fixer drop

White dots or light spots on the film caused by drops of fixer solution that was accidently spilled on the film before it was developed

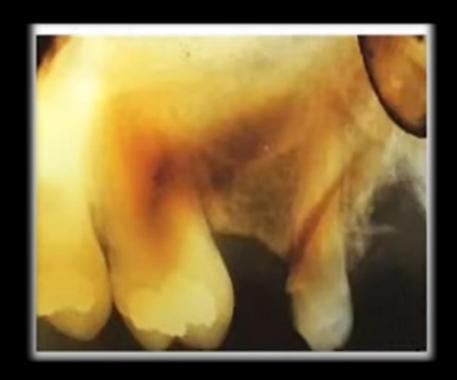
Yellow or brown stain

Stain or discoloration of film due to contaminated solution or insufficient washing
